Manhole Inspection Summary

Manhole # S23I__010MH

Location Address: **114 Lemmon St**

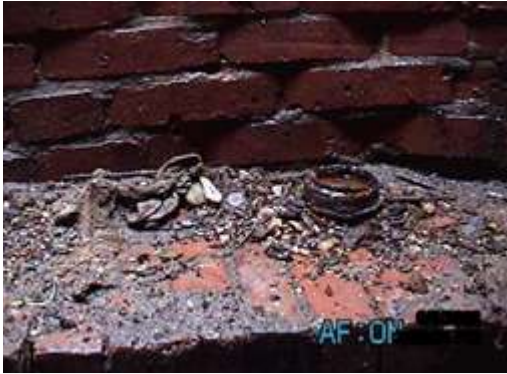
Misc

bench debris

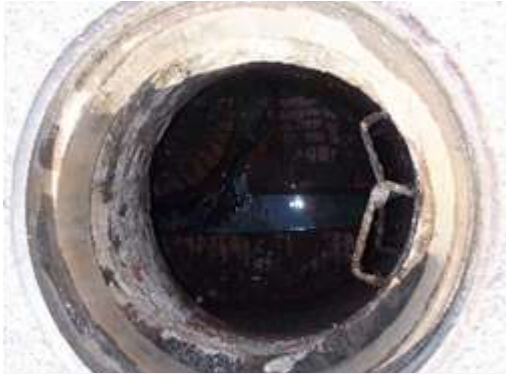
Defect 1

Offset: **2** (in.)

frame offset 2 inches

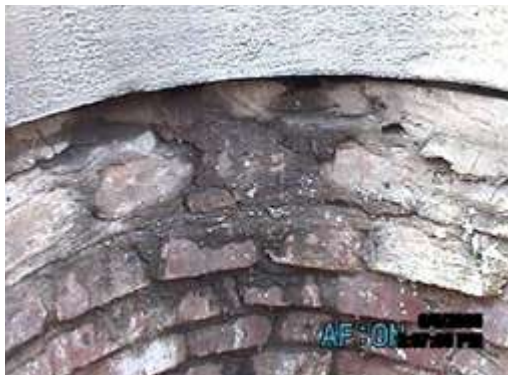
Defect 3

Condition: ☐ Sound ☐ Cracked ☒ **Leaks**

Infiltration: ☐ None ☒ **Joint** ☐ Cracks ☒ **Mortar** ☐ Roots ☐ Wall

frame infiltration at cover, chimney
influent at frame joint and mortar

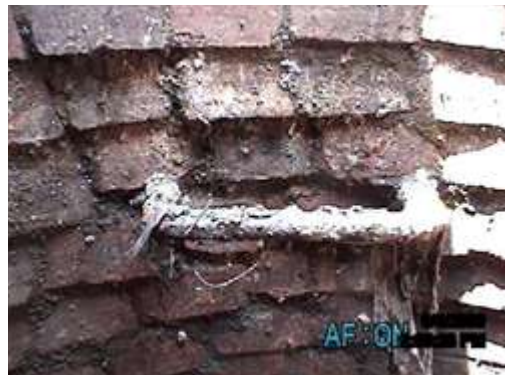
Defect 2

☒ **Evidence Of Surcharge** Depth: **9** (ft.) ☐ Active Surcharge Present

surcharge evidence 6 feet

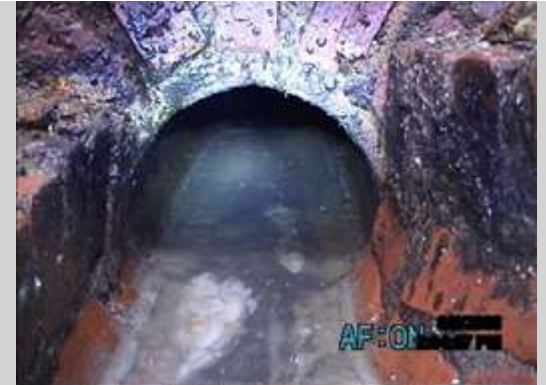
12 O'Clock Outflow

8 in. Circular Gravity Sewer
Pipe Out @ 12 O'Clock

Pipe Height: **8.4** (in.) Rod and Bar (Angled)
Pipe Material: **Clay** ☐ Pipe Lined
Invert Depth: **9.45** (ft.) Flow Characteristics: **Fast**
Deposits: ☒ None ☐ Mud ☐ Sludge ☐ Debris ☐ Grease
Silt Depth: **0** (in.) Deposits Extent:
Infiltration: **Evidence** Pipe Seal Cond: **Unknown**

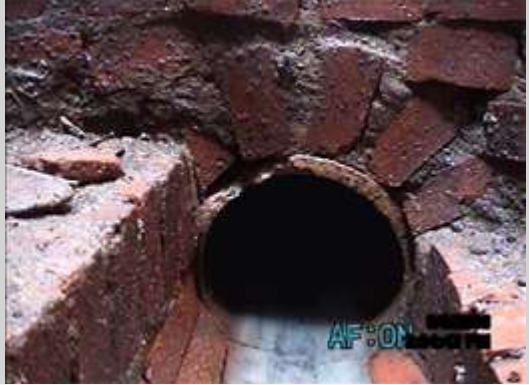
6 O'Clock Inflow

Infiltration: **Evidence** Pipe Seal Cond: **Unknown**
